**Smoky Canyon Mine  
Non-Time-Critical Removal Action (NTCRA) – 2015 Activities  
Pole Canyon Overburden Disposal Area**

**Weekly Construction Report**

Prepared by: Formation Environmental (on behalf of the J.R. Simplot Company)

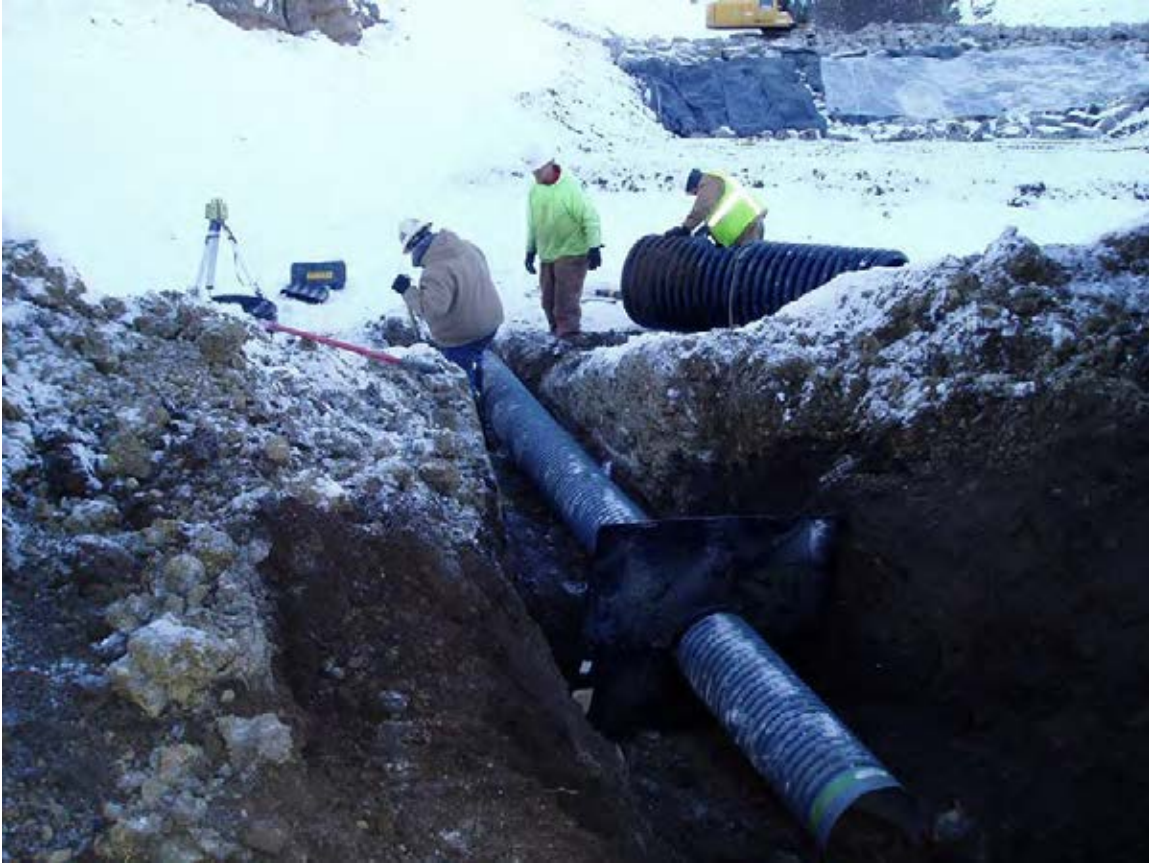
Photograph 6: Looking northwest (upstream) along 12-inch dia. pipe being installed for the low level flow outlet for the Northwest Sedimentation Basin. Note seep cutoff collar around pipe on upstream side of the embankment.

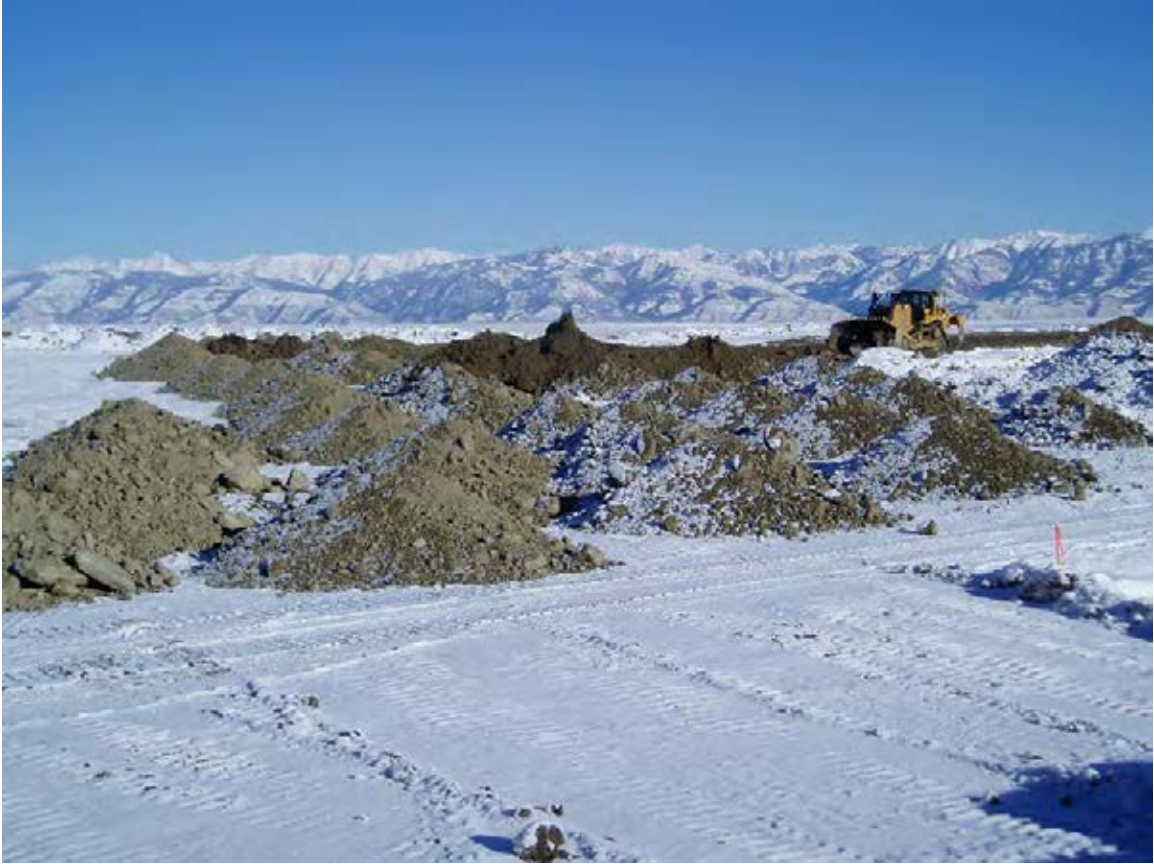
Photograph 7: Looking east at the top of the East Side ODA as a dozer spreads recently dumped Dinwoody material (from F-Pit). Approximately 5,000 cy were hauled to the top of the East Side ODA to fill-in low areas.

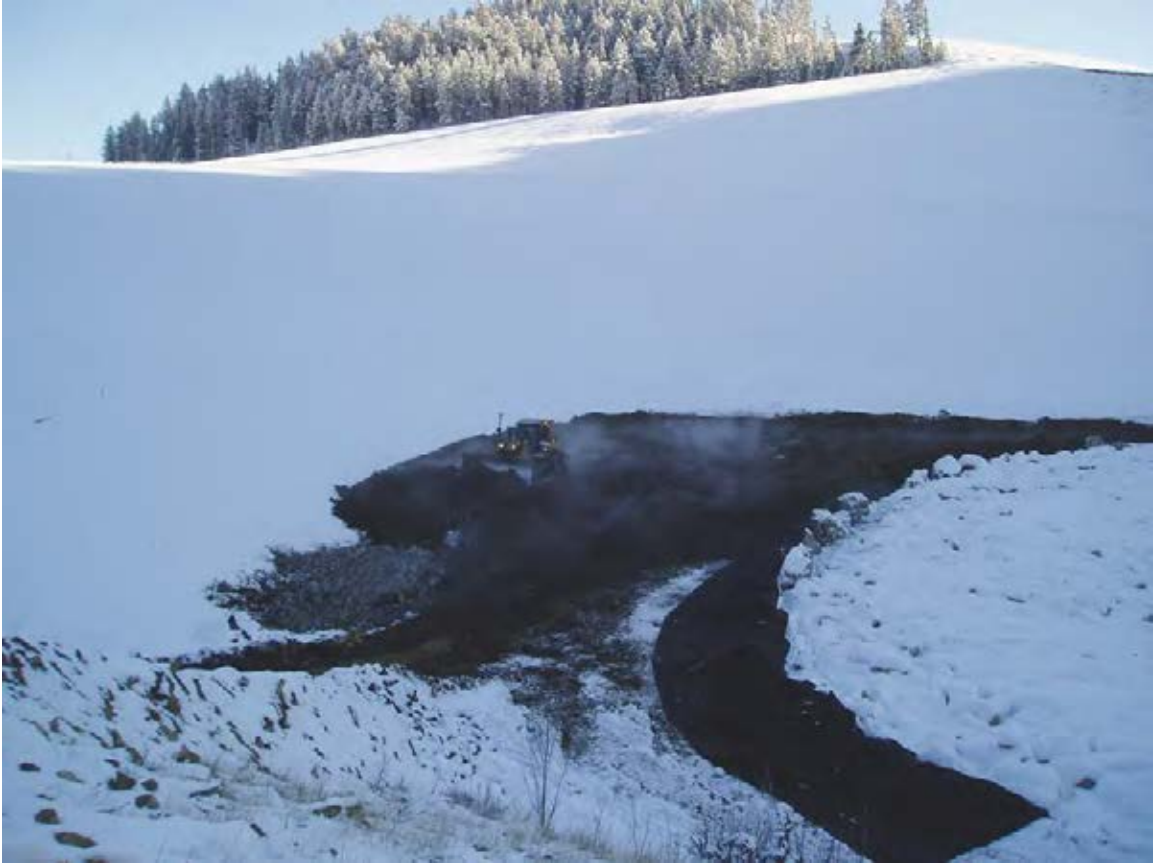
- West Side ODA Cover Construction
  - Place and track Dinwoody cover on lower west toe area above infiltration basin to promote drainage around riprap and geomembrane lined east slope of infiltration basin (Photograph 8). Geofabric placed against top row of boulders to keep sediment from washing into riprap lined face of basin (Photograph 9).

Photograph 8: Looking south at the West-side Toe of the ODA immediately above rip rap for infiltration basin as dozer grades Dinwoody to promote drainage around to the sides of the infiltration basin.

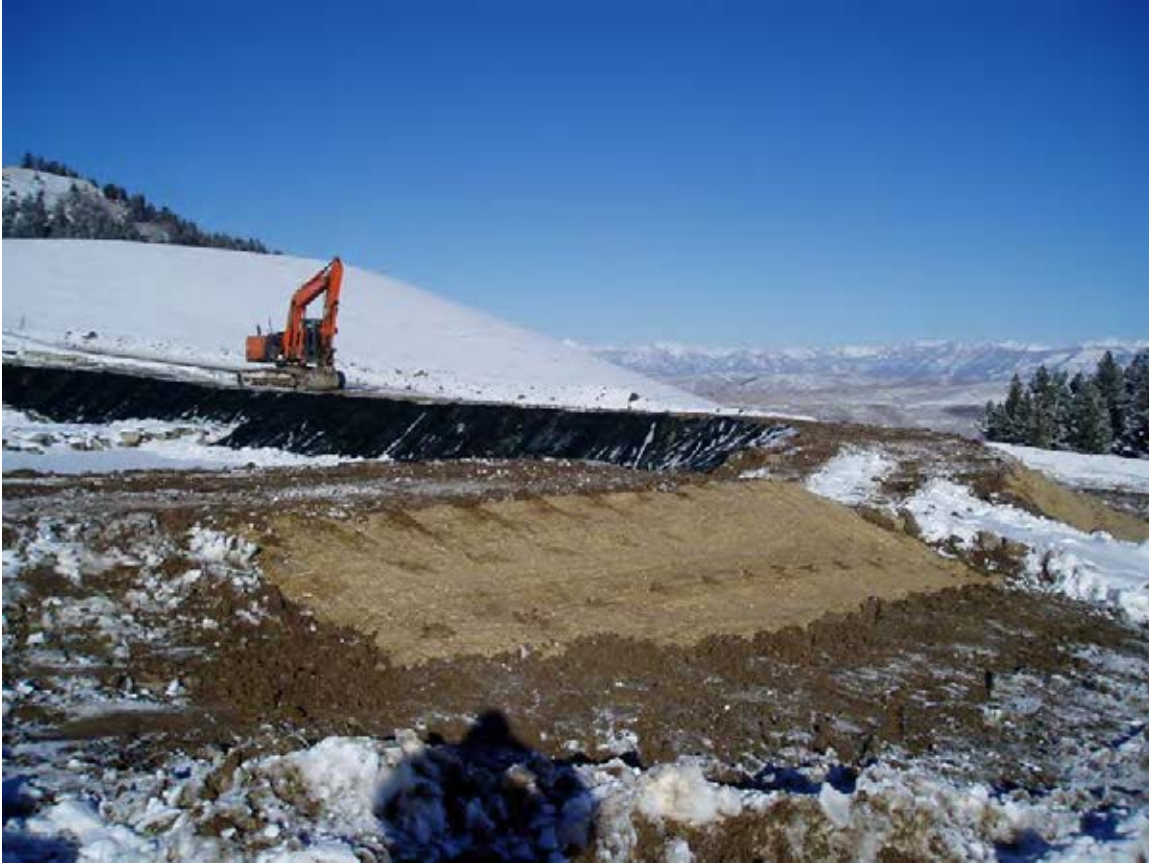
- 36-inch CMP Culvert Under Mine Haul Road (South End Culvert)
  - Substantially complete.
- West Side Runoff Control Ditch to South
  - Substantially complete.
- West Side South Sedimentation Basin
  - Substantially complete.
  - TRM placed on basin interior slopes, and straw matting placed on exterior slopes (Photograph 11).
  - Construct form (24-inch dia. HDPE pipe) and place concrete for low level outlet pipe riser.

Photograph 11: Looking northeast towards south embankment of the West-side West Sedimentation Basin and recently placed straw erosion matting on exterior of embankments and recently placed TRM matting on interior of embankments. Basin outlet is on the right side of photograph.

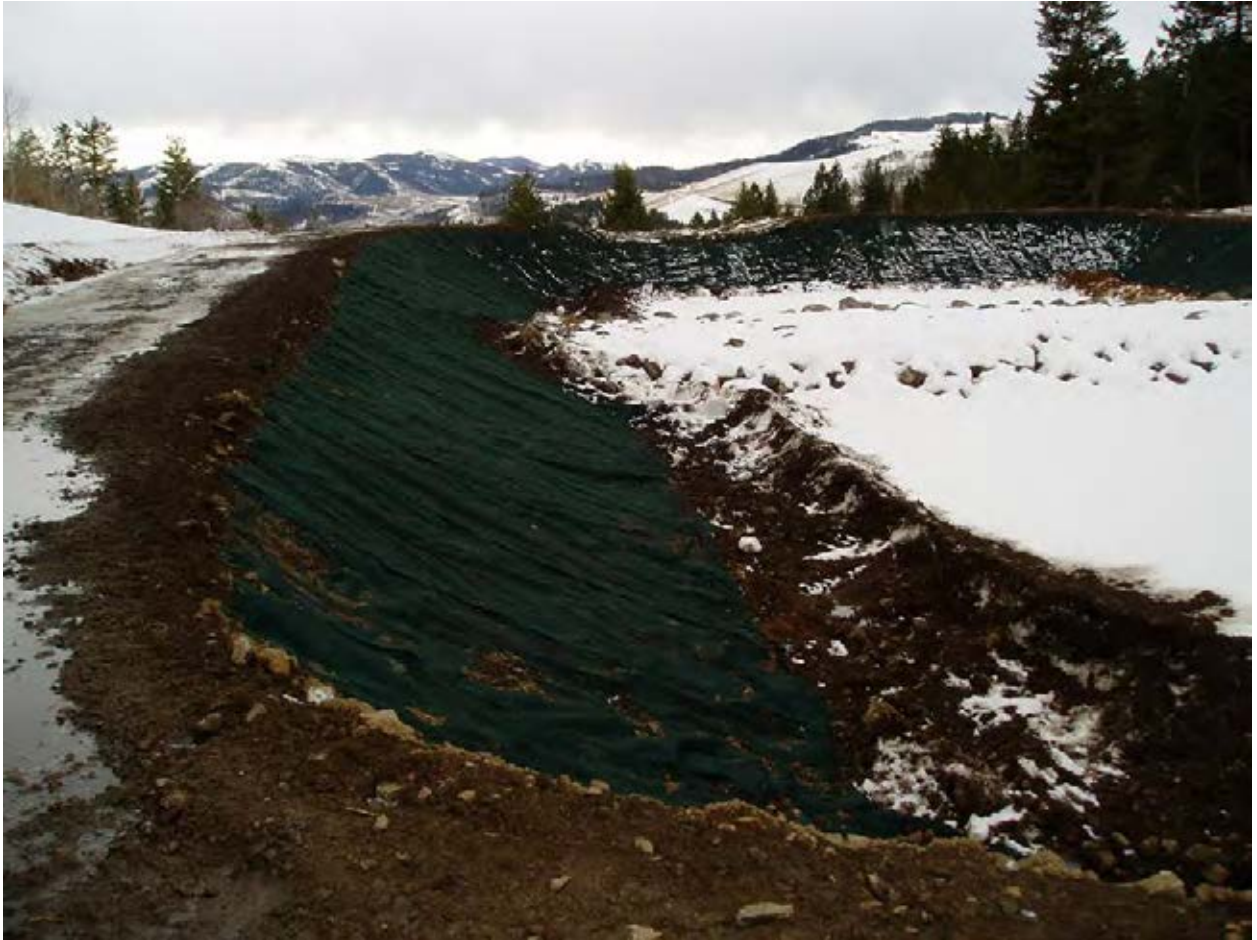
Photograph 1a: Looking south along the east side embankment of the Saddle Infiltration Basin and recently placed TRM lining on basin interior side slopes.

- Substantially complete.
- Saddle Infiltration Basin
  - Install TRM lining on basin interior side slopes (Photograph 1a and 1b).
  - Substantially complete.

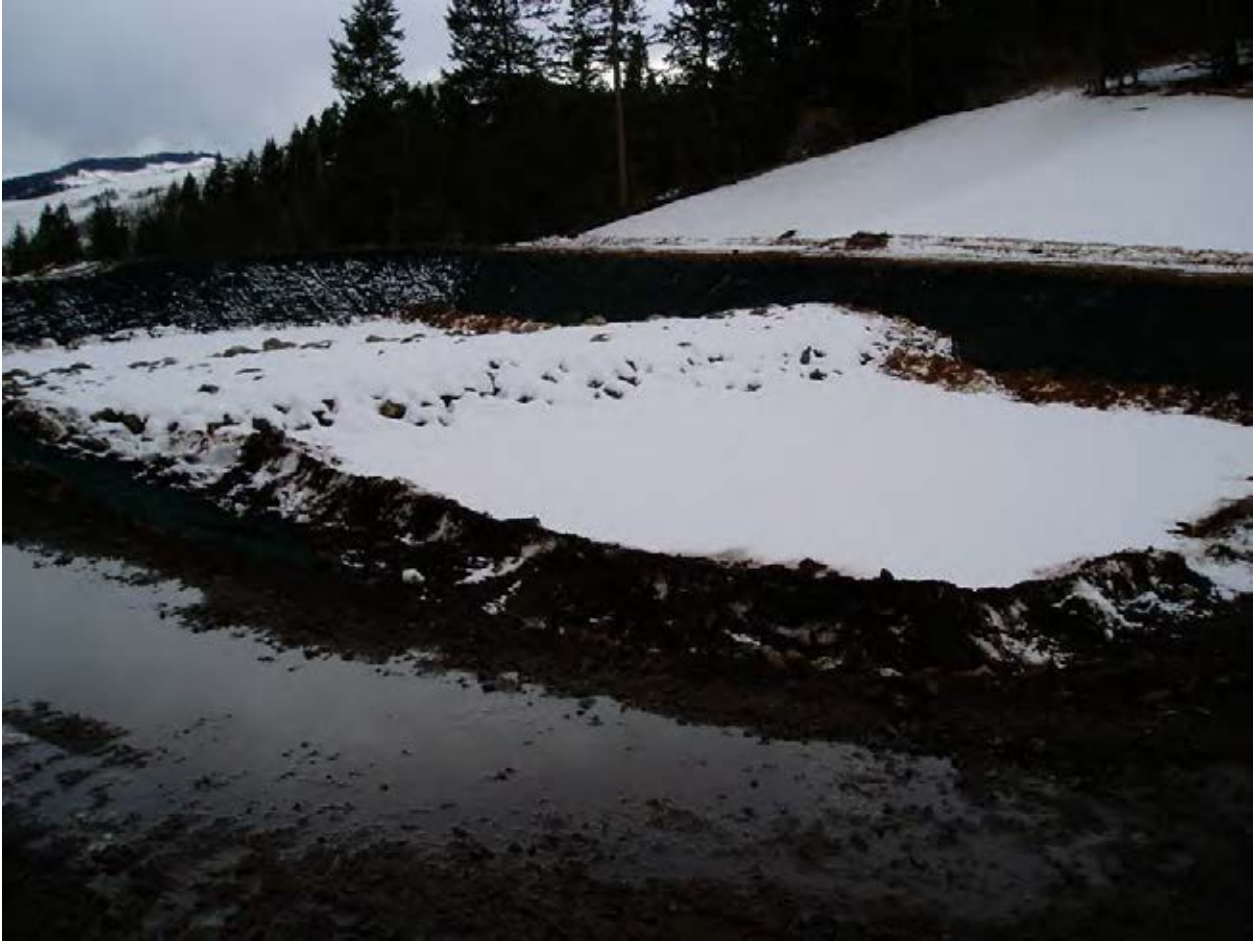
Photograph 1b: Looking southwest from northeast corner of the Saddle Infiltration Basin and recently placed TRM lining on basin interior side slopes.

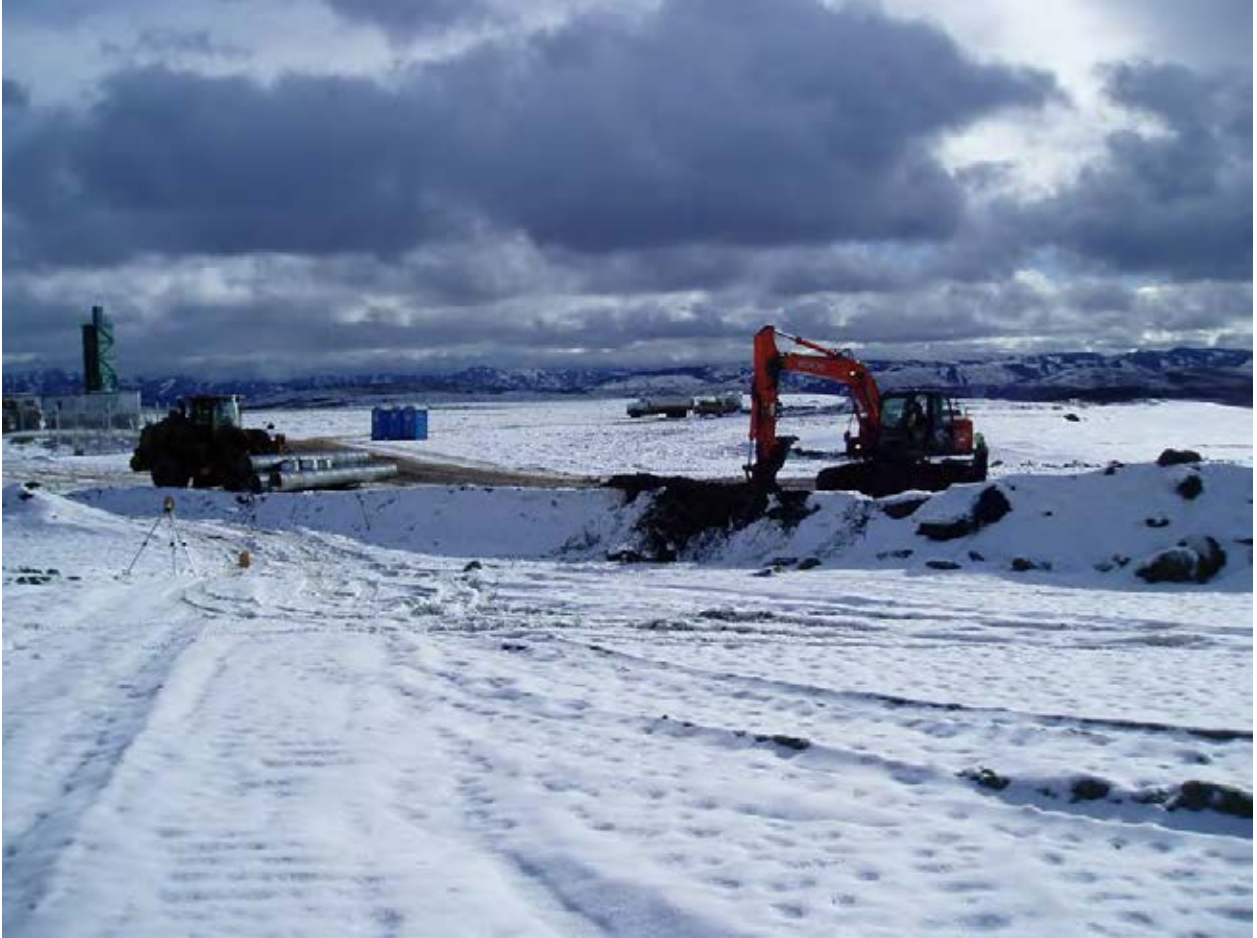
Photograph 2a: Looking east across the top of the east side ODA as back hoe excavates trench for the installation of the 24-inch diameter CMP culvert under access road to blast complex. Culvert need to connect the upper portion to the lower portion of the East Side Haul Road Runoff Control Ditch.

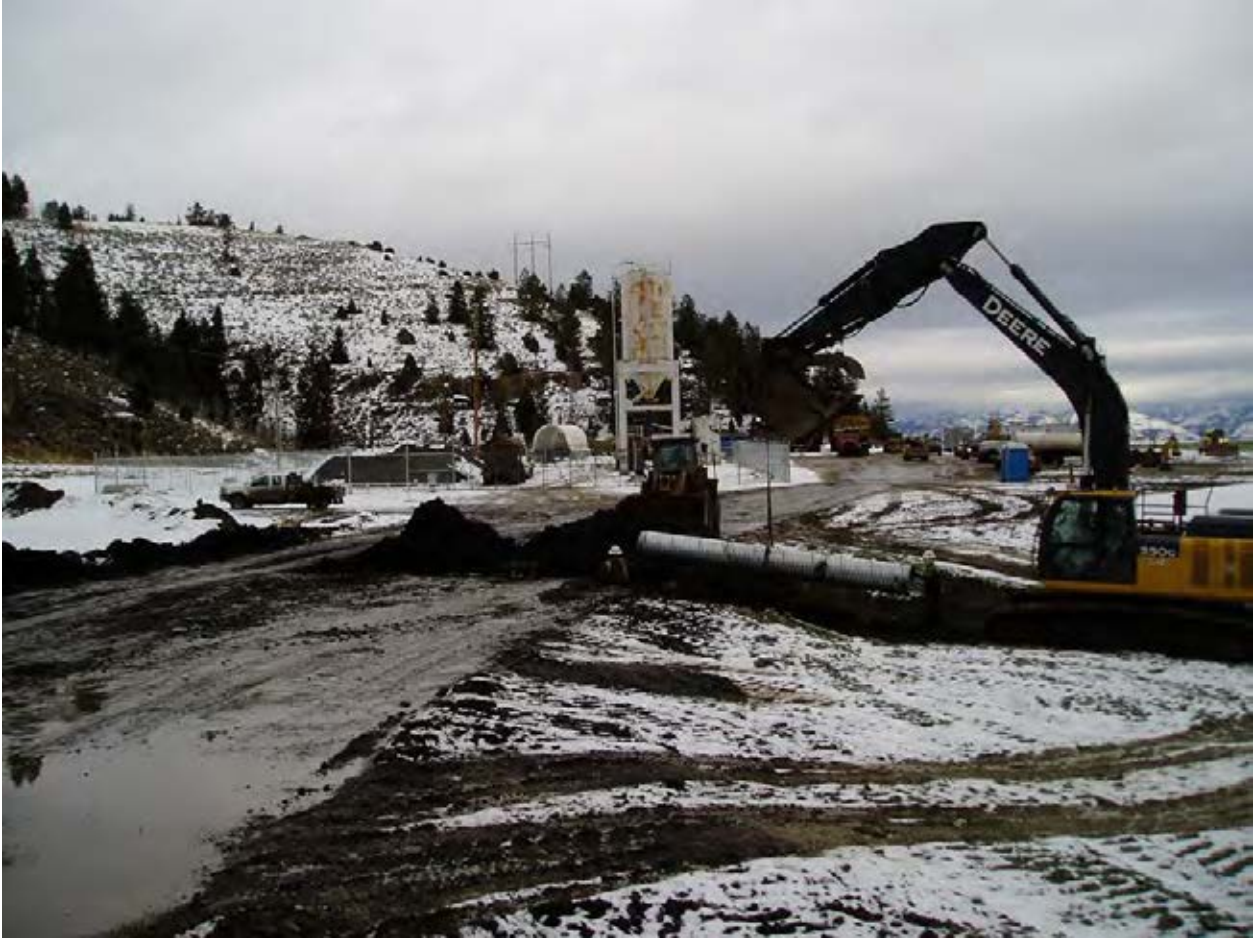
Photograph 2b: Looking northeast towards blast complex as back hoe places last section of the 24-inch diameter CMP culvert under access road needed to connect the upper portion to the lower portion of the East Side Haul Road Runoff Control Ditch.

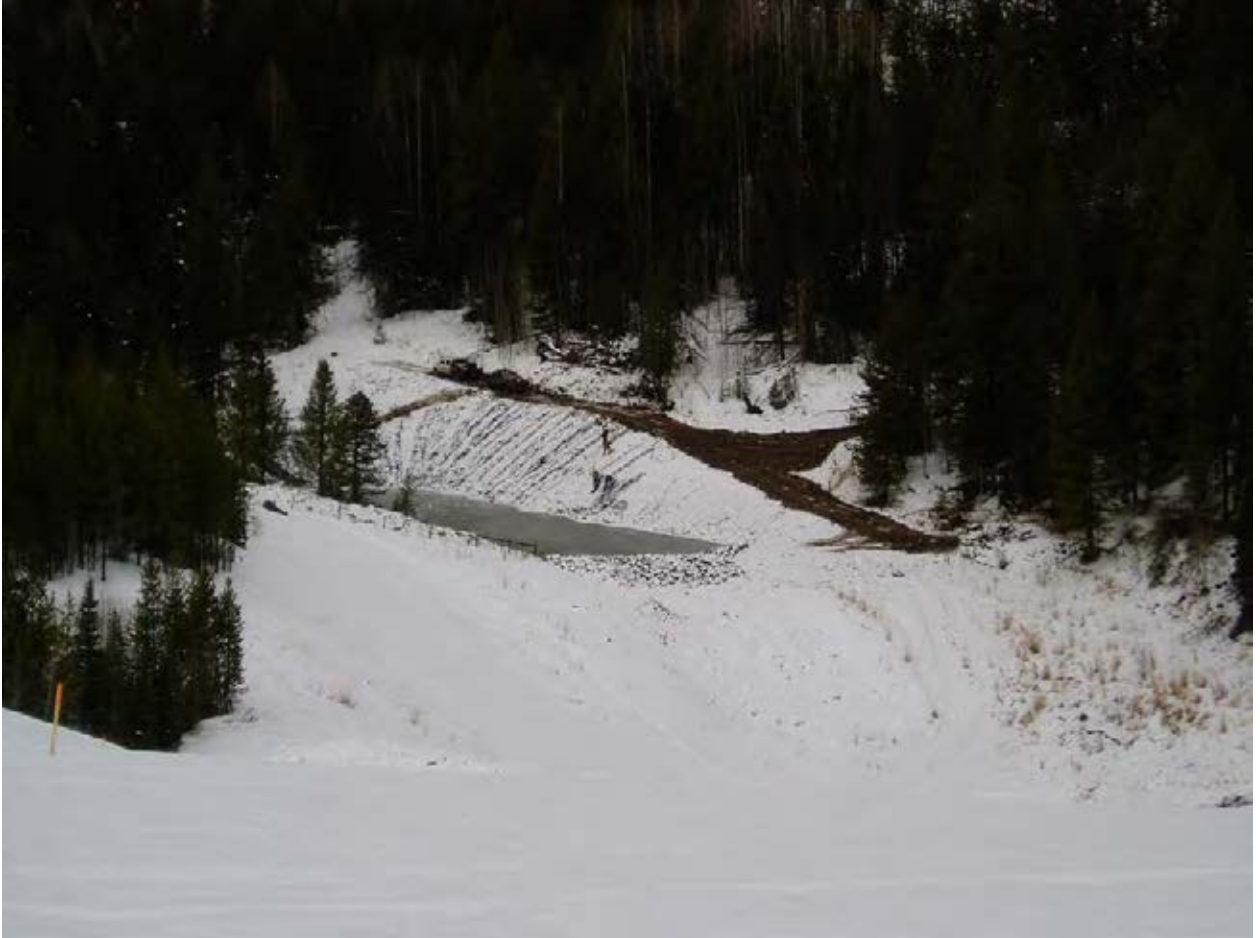
Photograph 3a: Looking west towards West Side Sedimentation Basin as workers install TRM lining on basin interior side slopes.

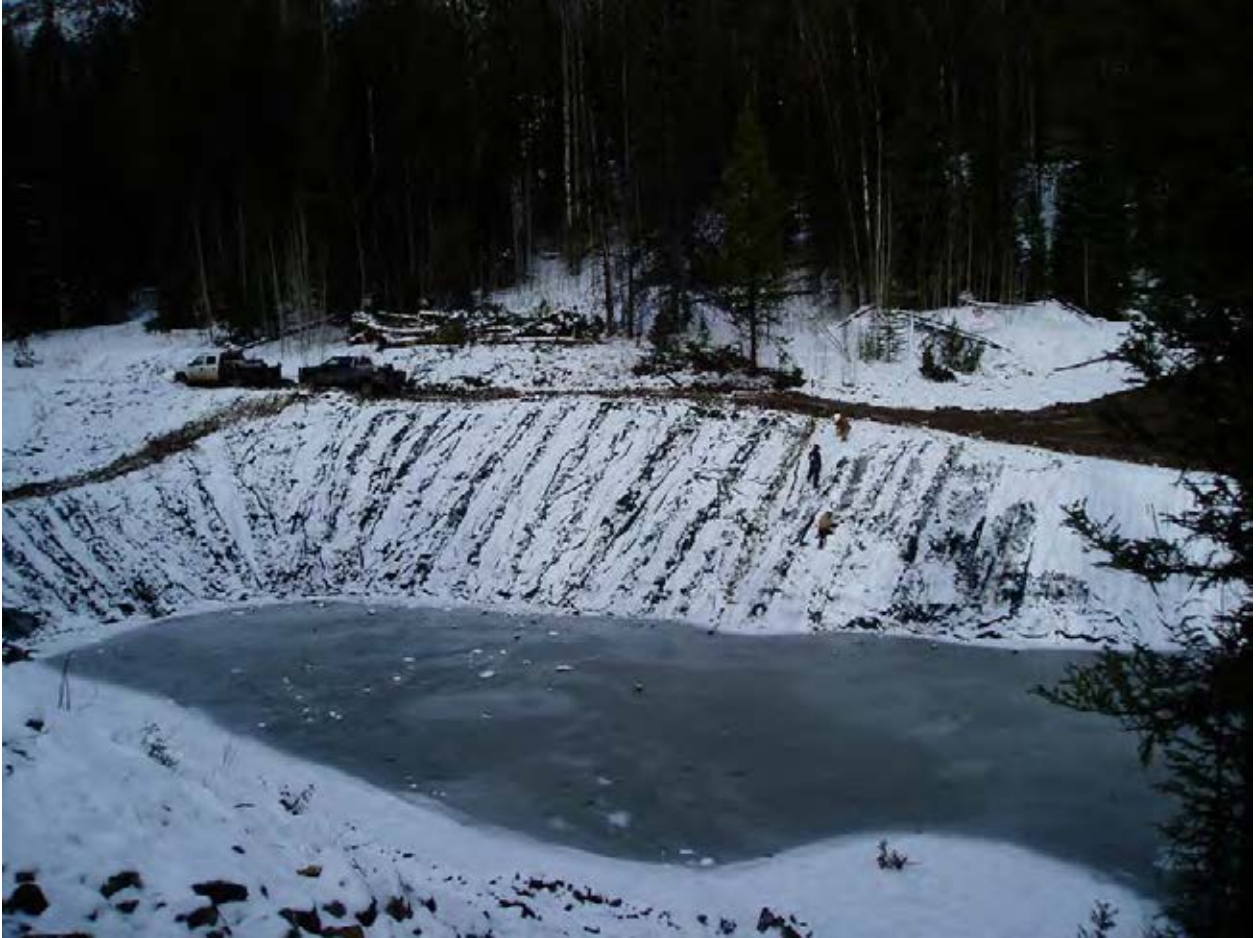
Photograph 3b: Looking north at north bank of the West Side Sedimentation Basin as workers install TRM lining on basin interior side slopes.

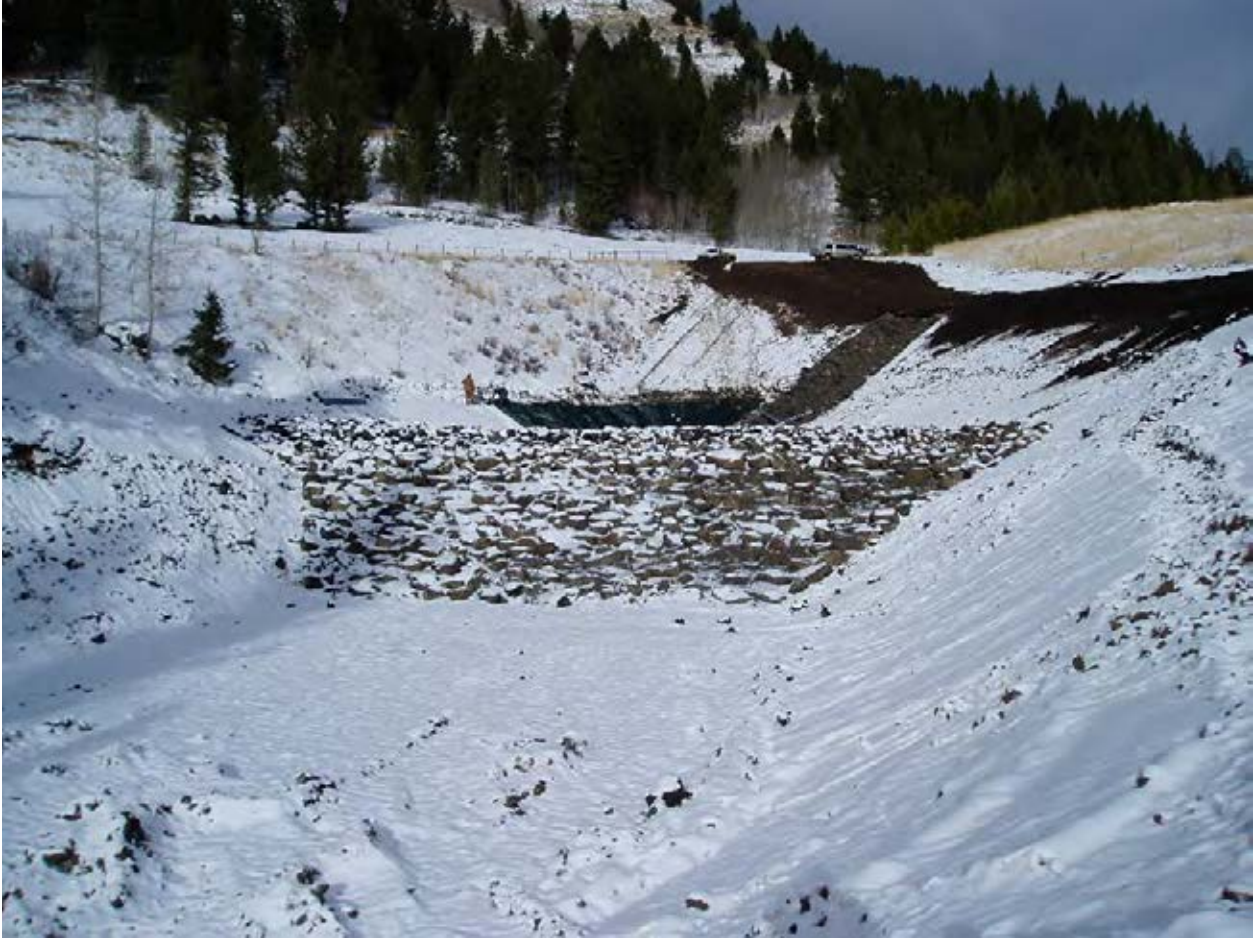
Photograph 4a: Looking north-northwest from Cell 2 towards Cell 1 of Northwest Sedimentation Basin as workers in background install TRM lining on basin side slopes.

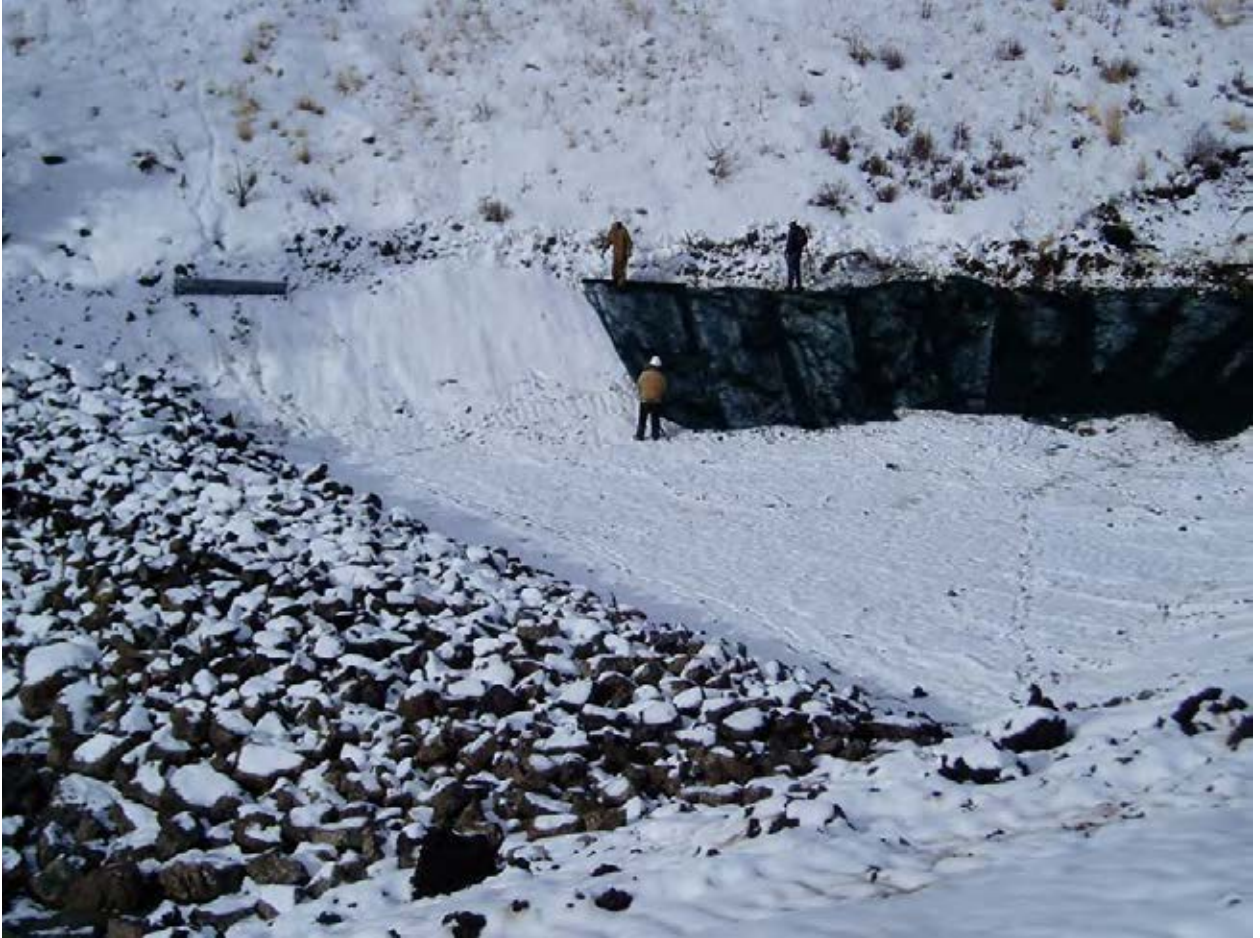
Photograph 4b: Looking west towards west bank of Northwest Sedimentation Basin as workers install TRM lining on basin side slopes.

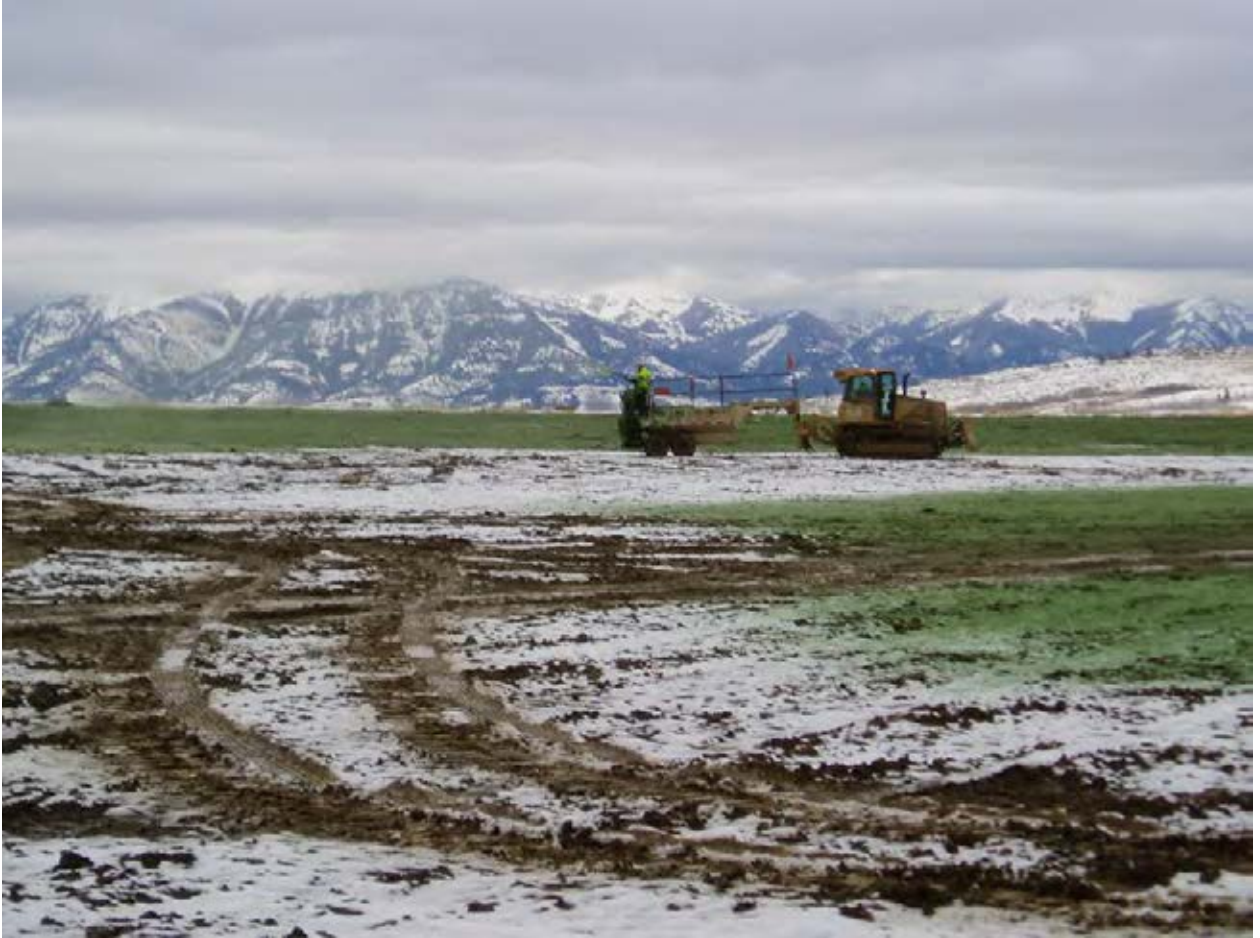
Photograph 5a: Looking east across the top of east side ODA as hydro-seeder applies hydro-mulch and seed.

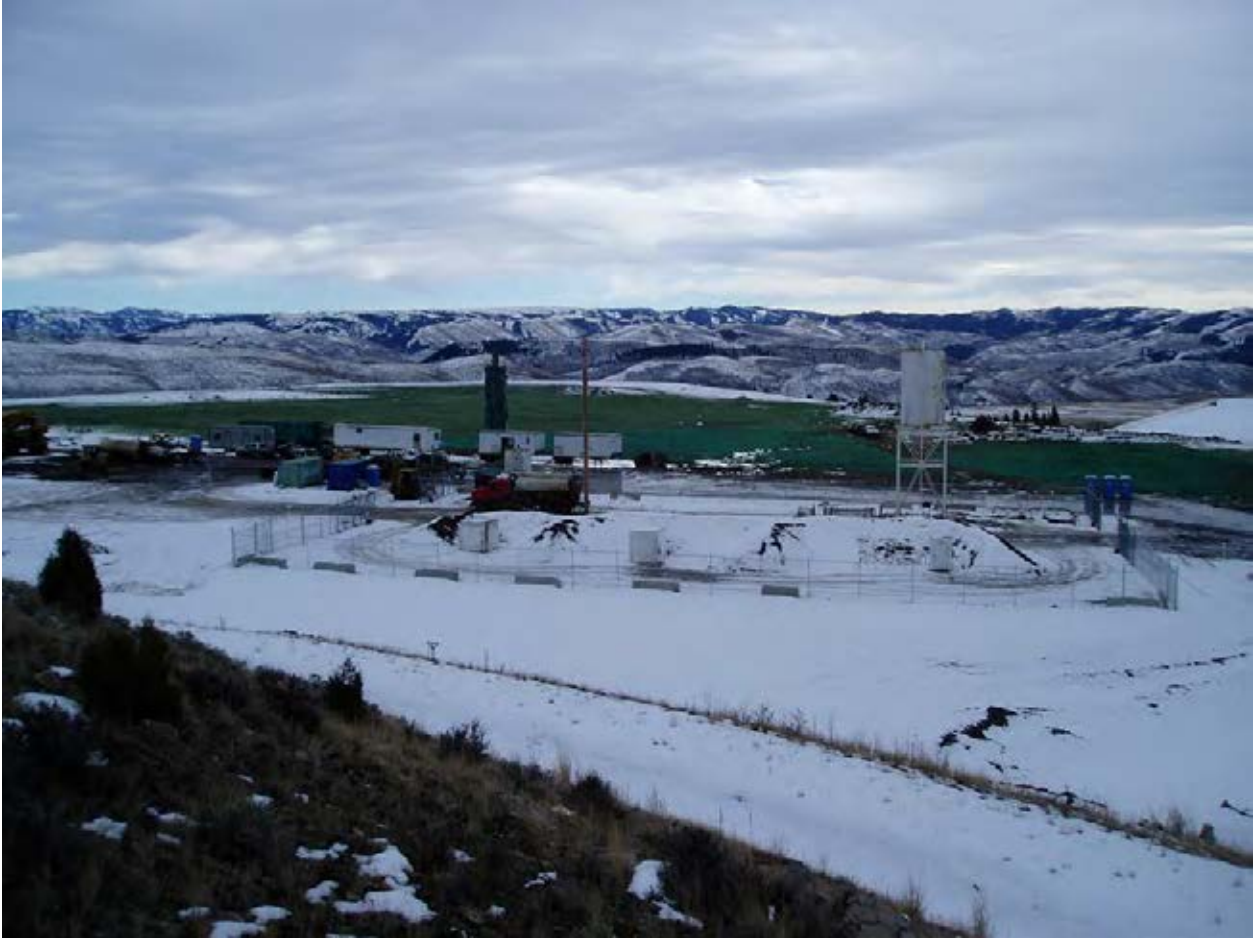
Photograph 5b: Looking east at the blast complex and top of the east side ODA and area covered with hydro-seed and mulch.

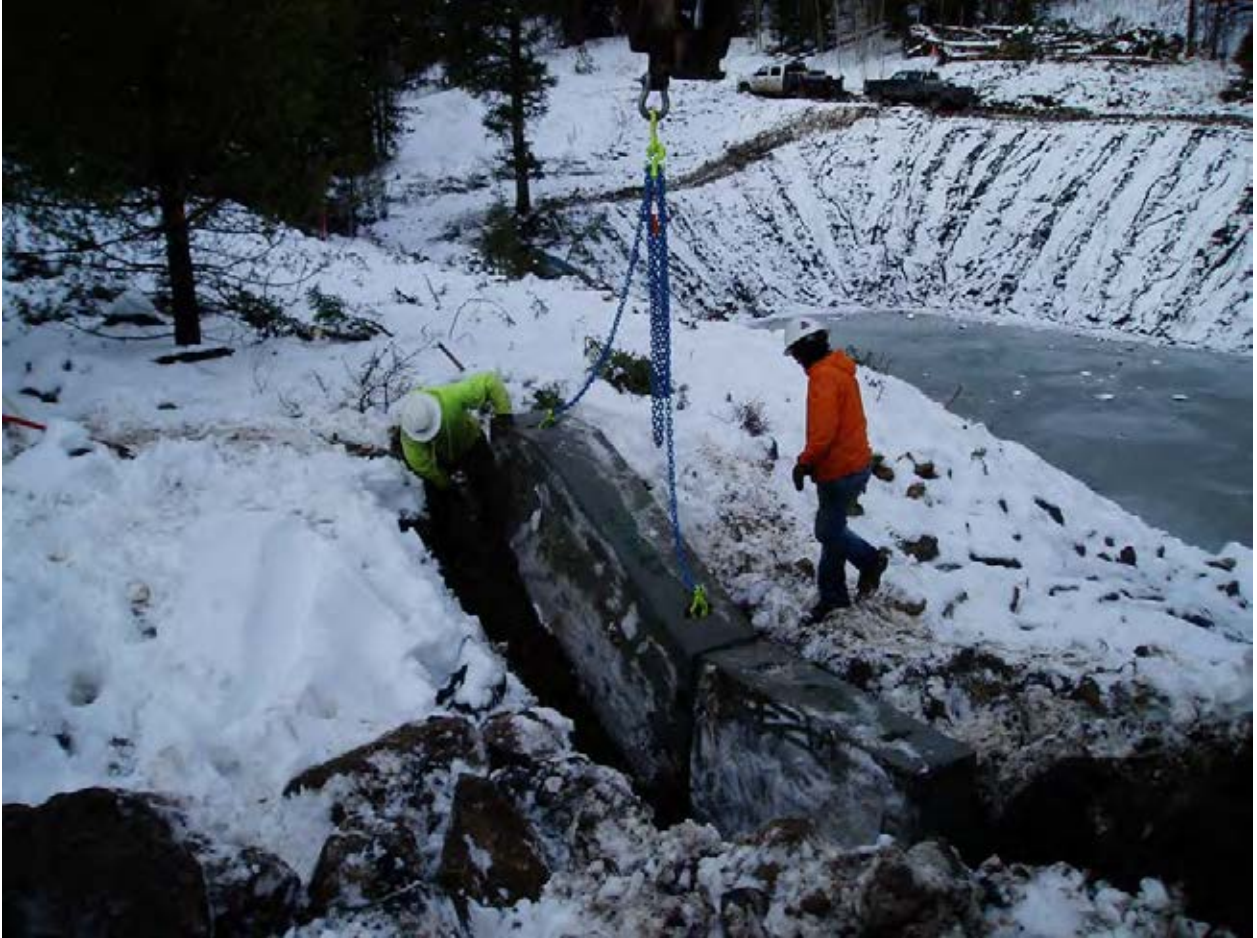
Photograph 6: Looking west as workers install pre-cast concrete cutoff wall at the top of the West Side Runoff Control Ditch outfall to the West Sedimentation Basin.

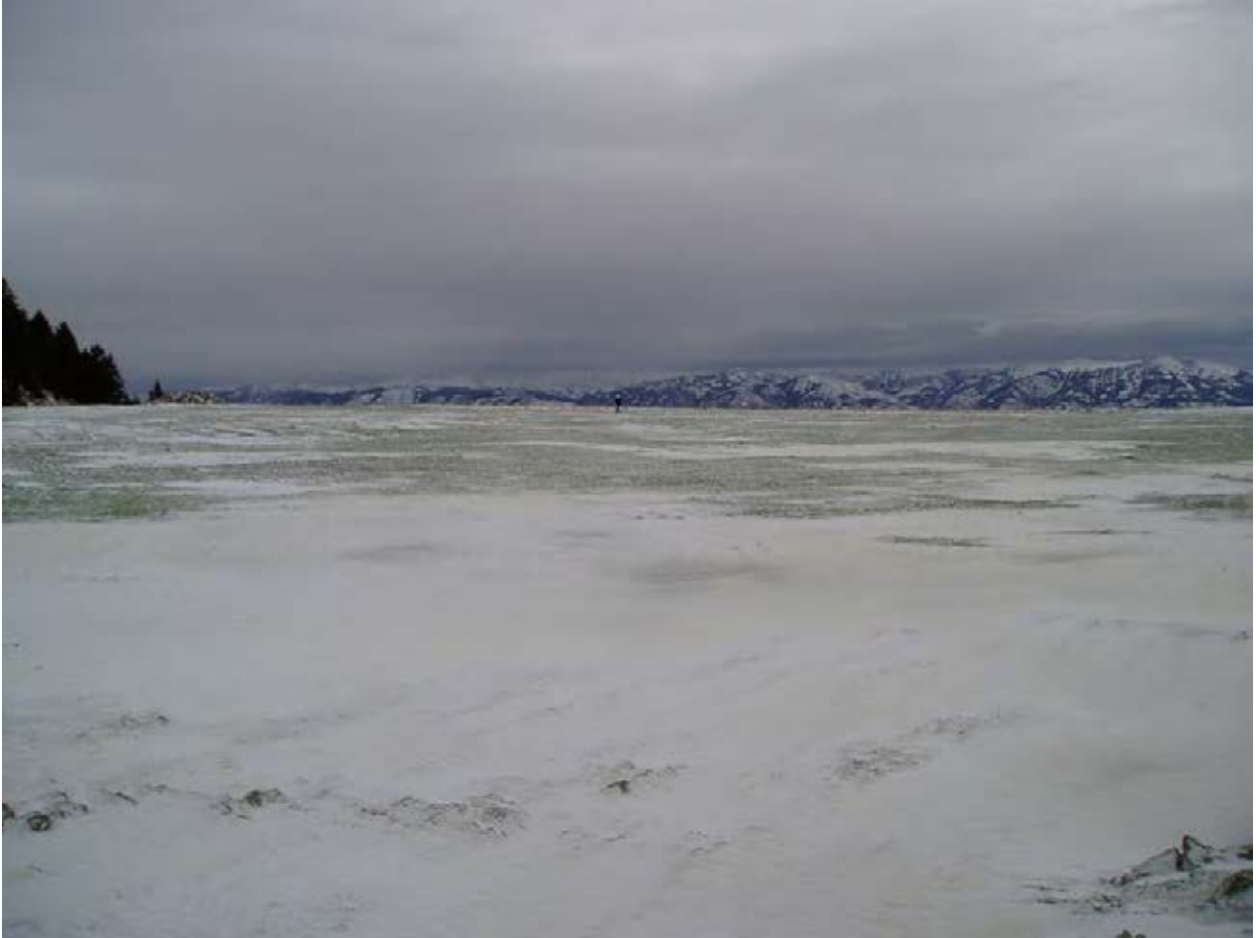
- CQC surveying with GPS unit to document as-built condition of east side top surface and elevation profile of east side haul road runoff control ditch (Photographs 7a and 7b).

Photograph 7a: Looking east across the top of the east side ODA as grade check takes survey control points with GPS unit to determine surface topography.

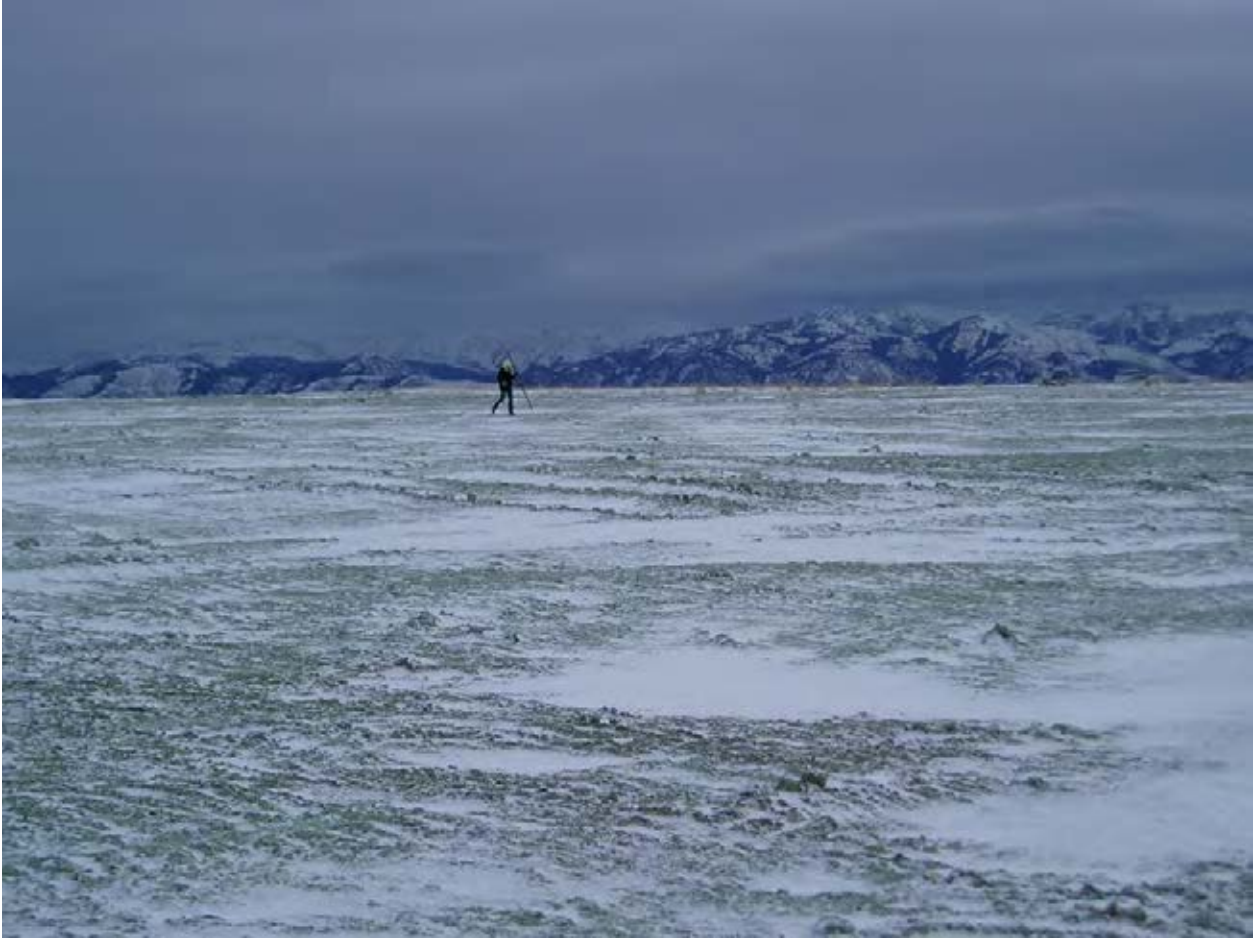
Photograph 7b: Close-up view of image in Photograph 7a, as grade check takes survey control points with GPS unit to determine surface topography.
